Report No. : HS0809170035A Version : A

# RAIN AND DUST TEST REPORT

Company : Gold Apollo Co., Ltd

Sample Name : <u>VP101</u>

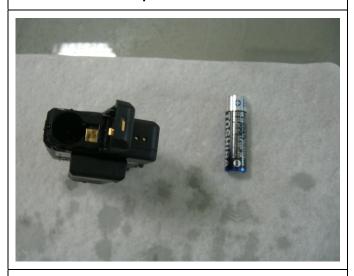
# Attachment 2: Photo of unit after rain test

After testing, visual inspection showed no water permeated into the units and units' vibration, lights and sounds were normal.

## No water permeated into units

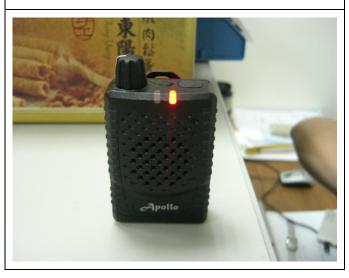
**Functions were normal**

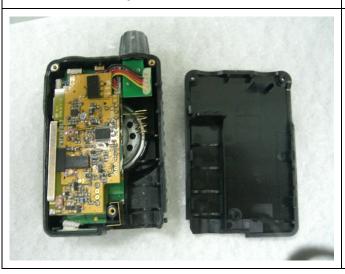
After testing, visual inspection showed no particles permeated into the unit and units' vibration, lights and sounds were normal.

No dust permeated into units-2

No dust permeated into units-3

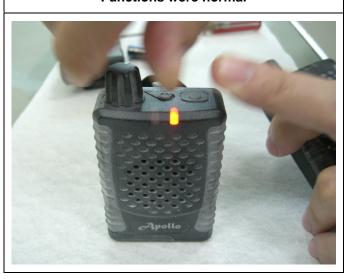
## **Functions were normal**
